HAZARDOUS MATERIALS SURVEY

BUILDING 160
WHITE SANDS MISSILE RANGE

WSMR Contract No: DATM05-01-P-0221
WSMR Work Order No: P00007
VIVA Project No.: WSMR.14.1.36
Issue Date: July 30, 2002

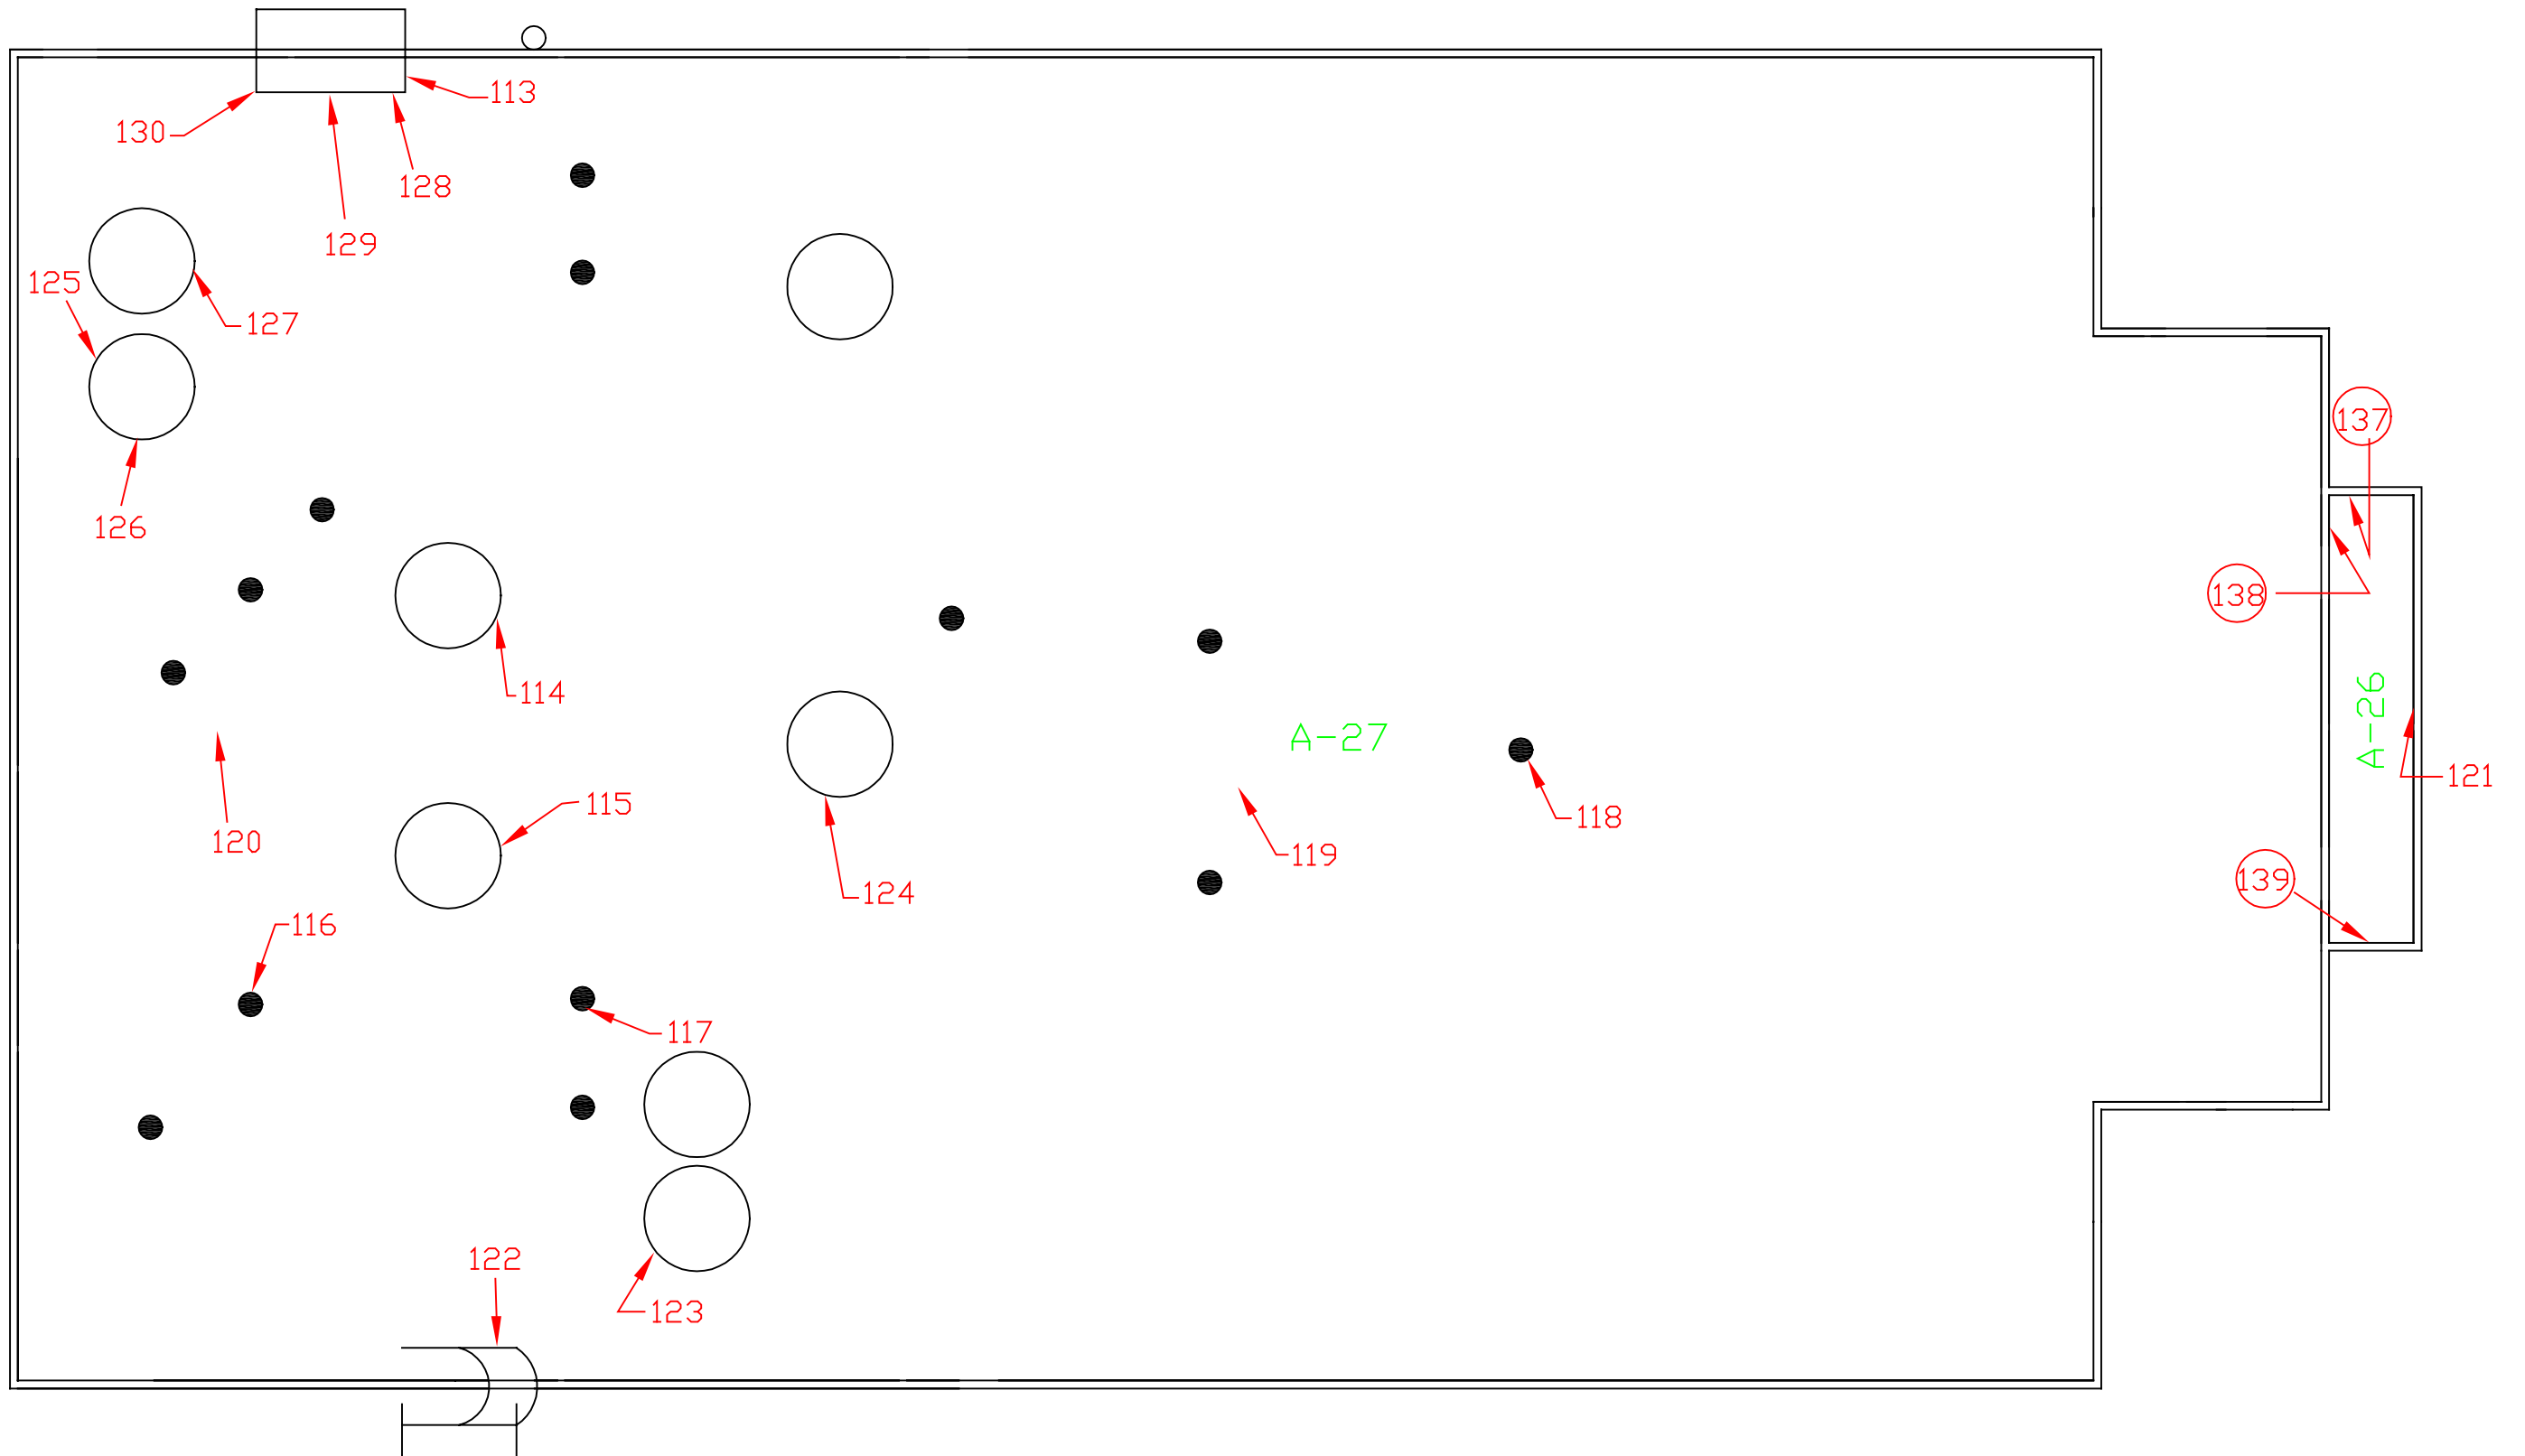
DRAWN BY: R.B.	REVIEWED BY: G.G.	APPROVED BY: M.W.	JOB NO. WSMR.14.1.36	TITLE: ASBESTOS SAMPLES	DATE: 07/12/02
VIVA ENVIRONMENTAL, INC. 7201 STILES DR. EL PASO, TX.79915			NAME BUILDING 160 ASBESTOS ROOF LOCATIONS WHITE SANDS MISSILE RANGE, N.M.		
DRAWING NO. 03			SCALE: NTS

- 122 Sample Locations
- 17 Positive Sample Locations
- A-27 Area Locations

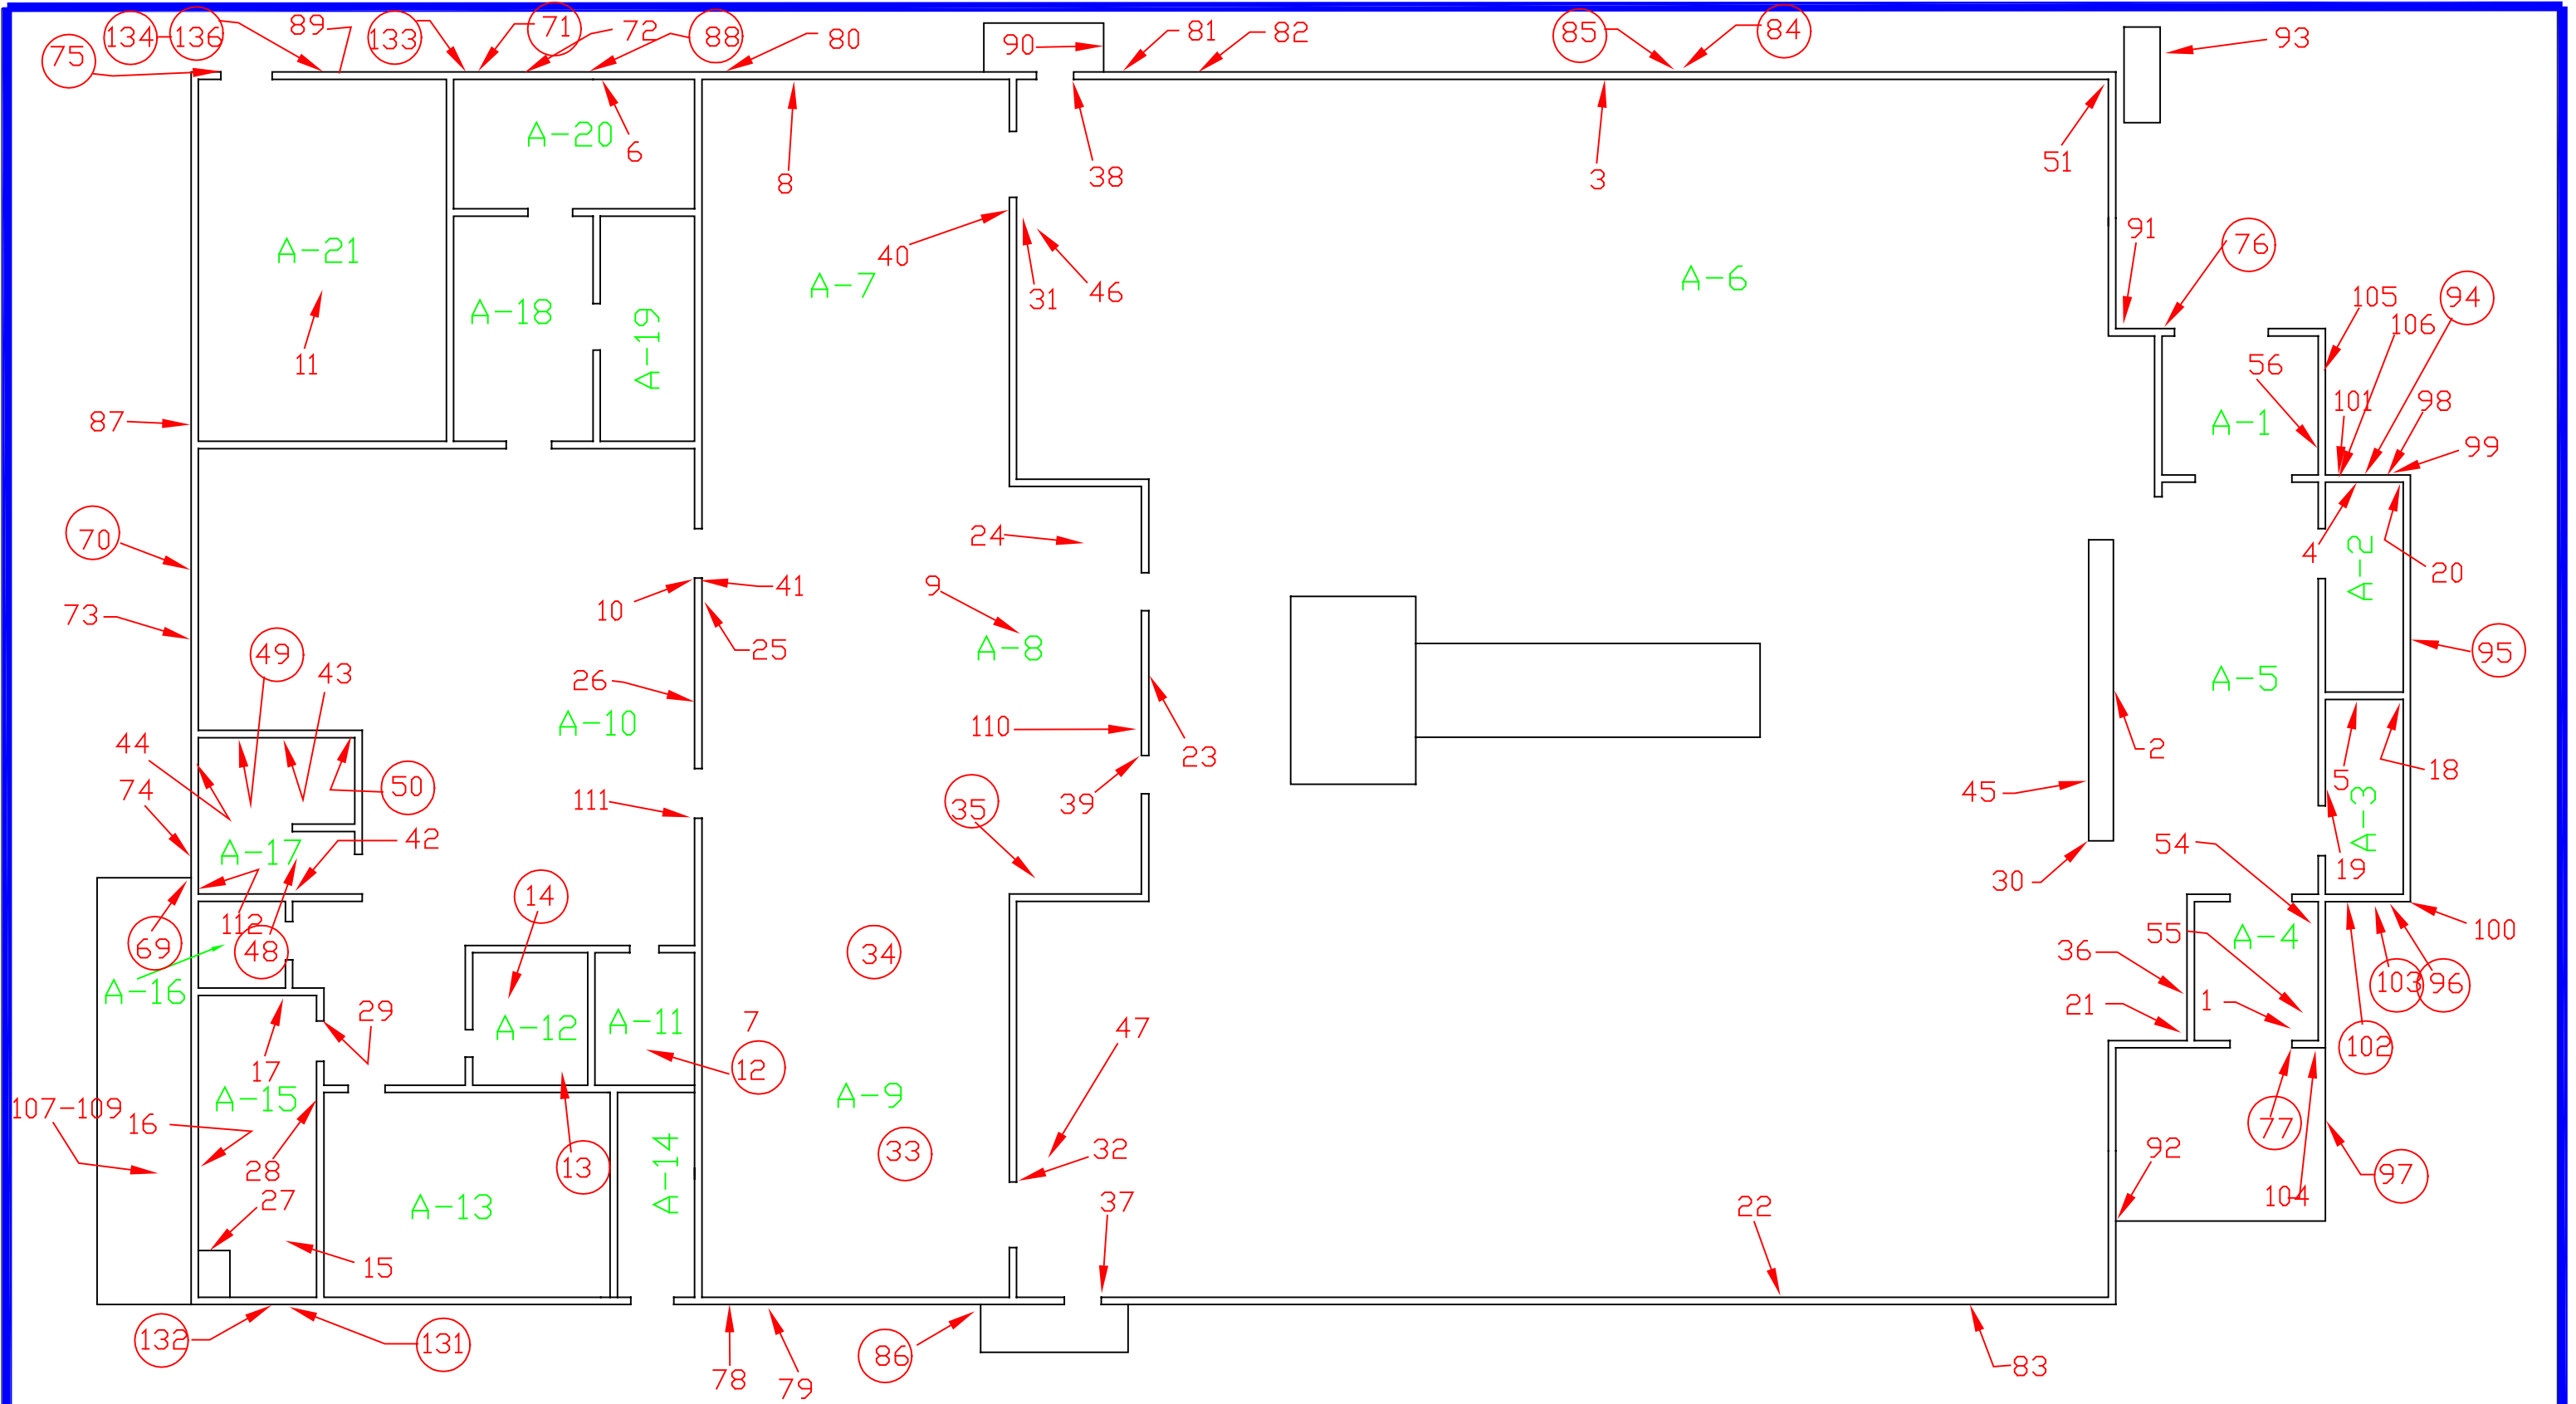
- 17 Sample Locations
- 17 Positive Sample Locations
- A-13 Area Locations
